A Prescription for Medical Campus Asset Management

2021 ESRI Infrastructure Management &
GIS Conference

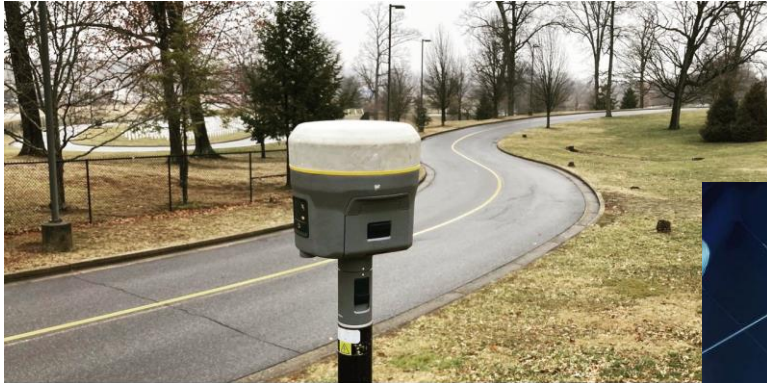
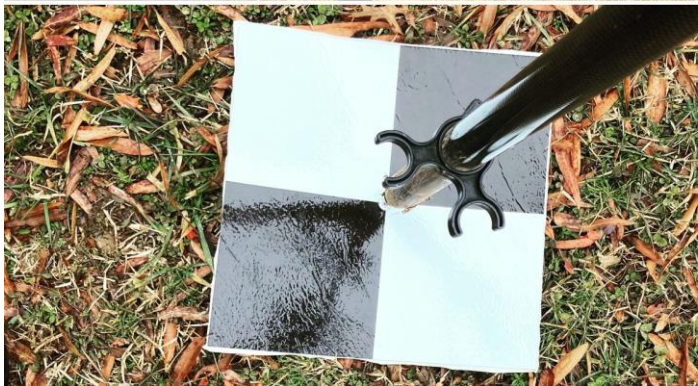
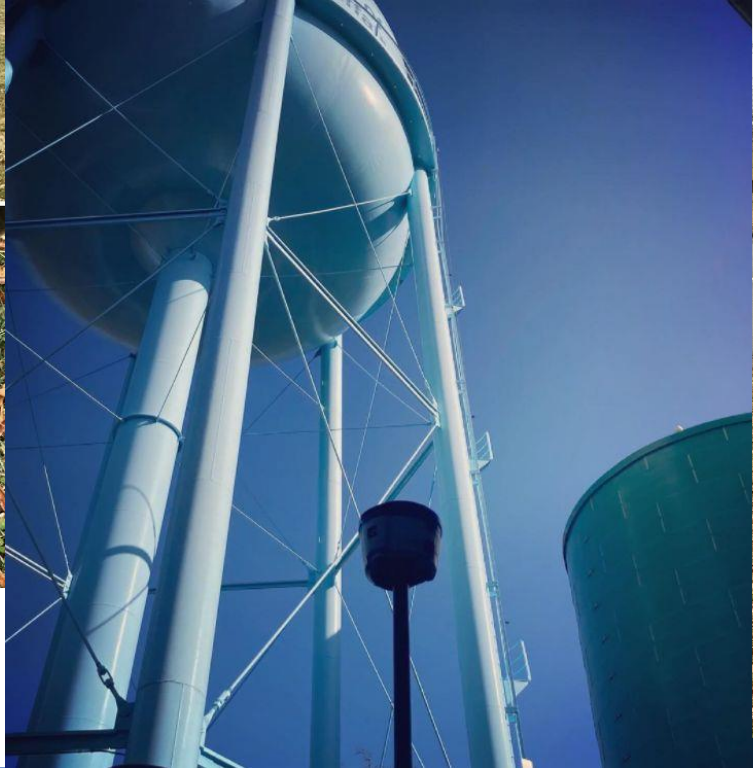
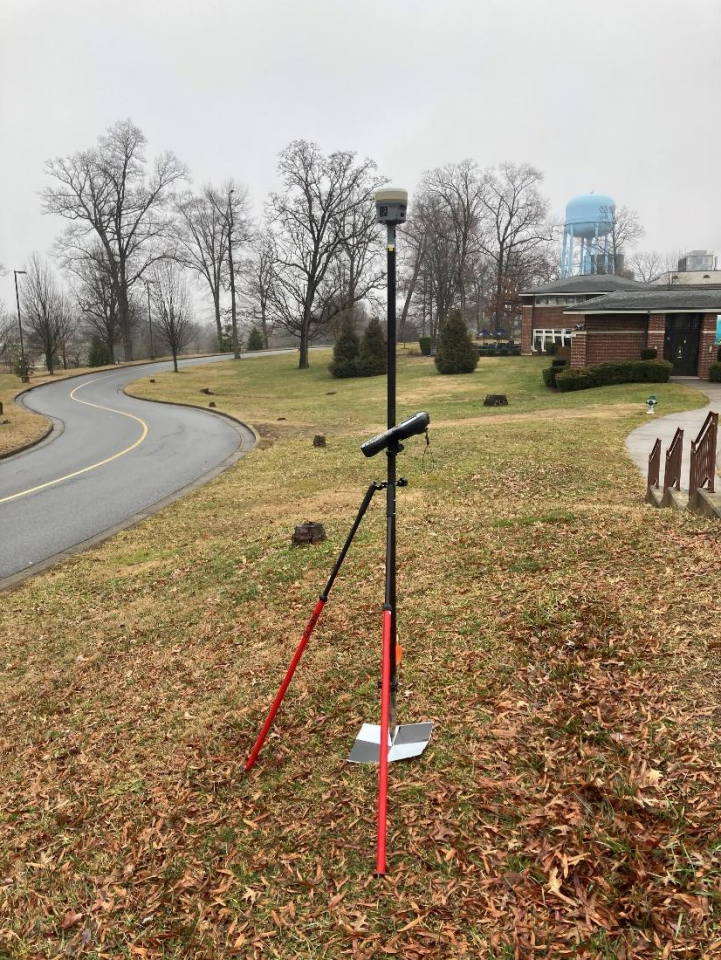
UAV Control Placed

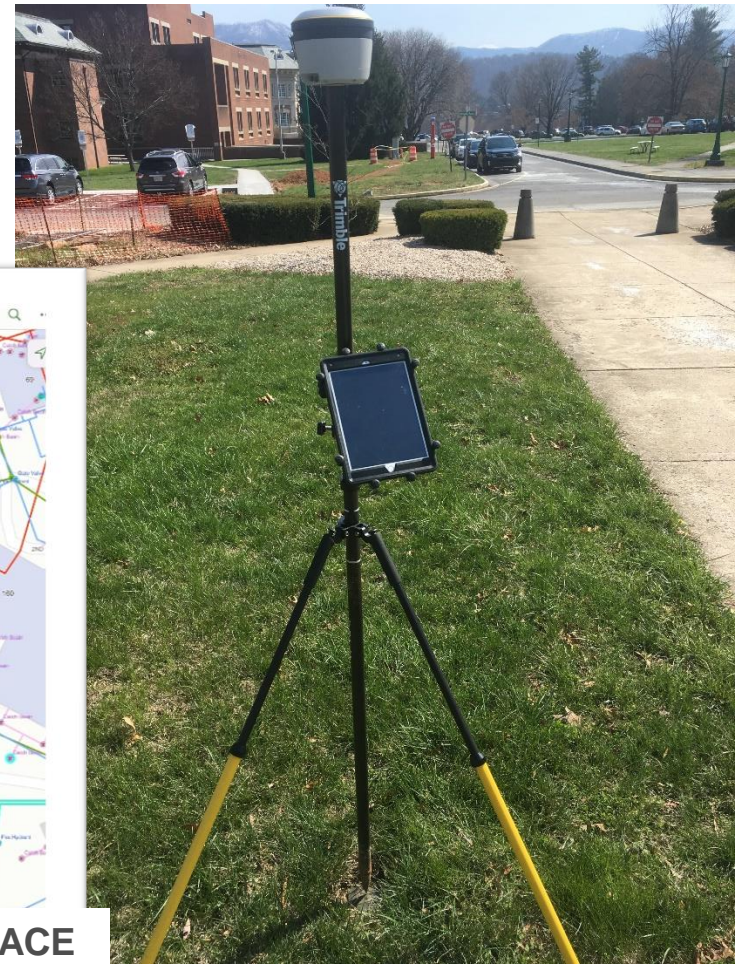
MOBILE DEVICE INTERFACE
