# WASTEWATER ASSET MANAGEMENT

*Minimize Risk and  
Optimize Performance*

NORTH  
TEXAS  
MUNICIPAL  
WATER  
DISTRICT

## **Collection System Capacity, Management, Operation, and Maintenance Plan**

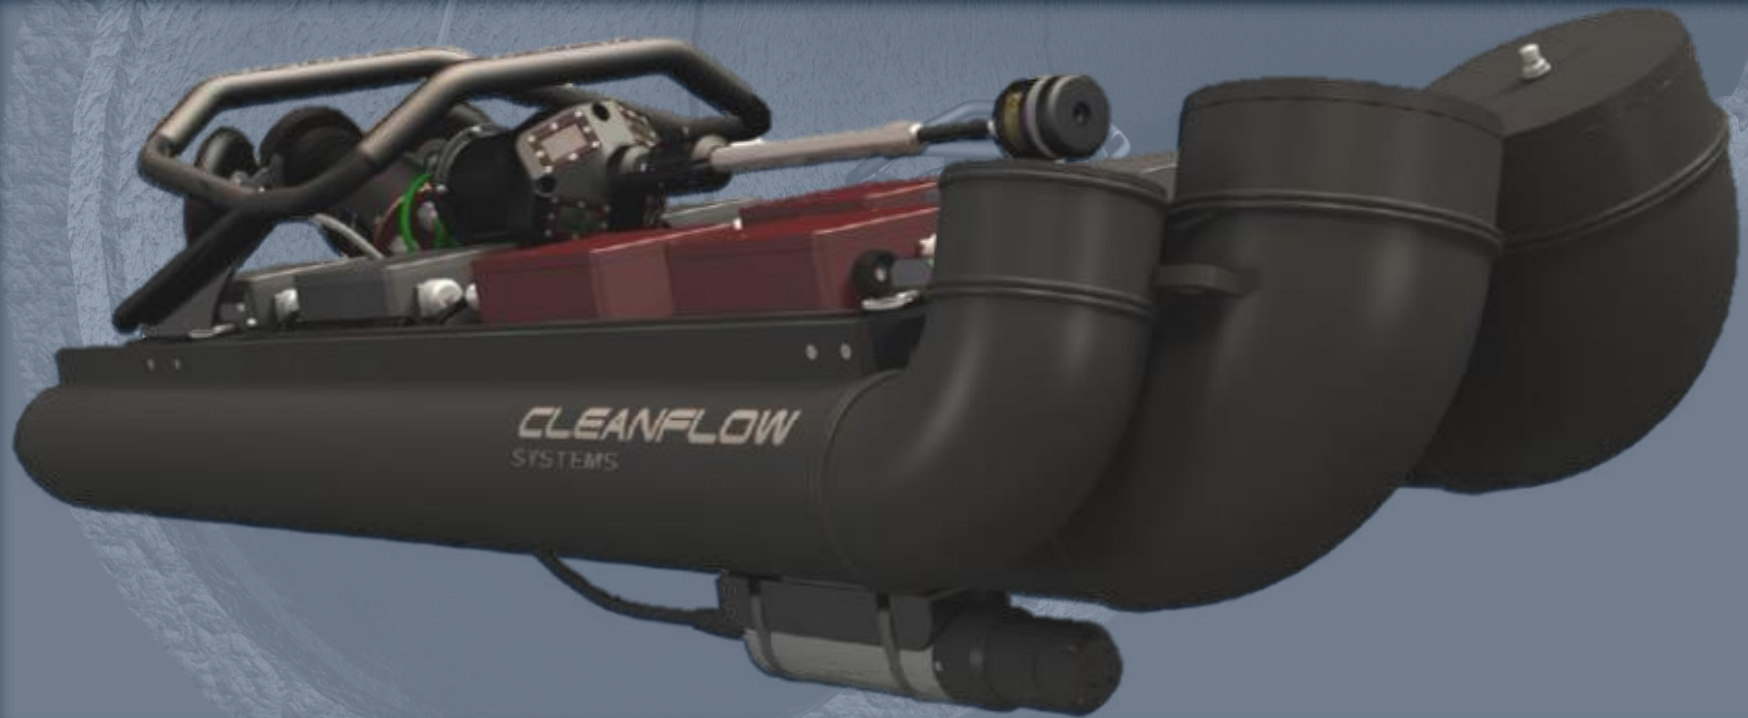
**HD Camera  
Module**

**3D Laser  
Module**

**Sonar Module**

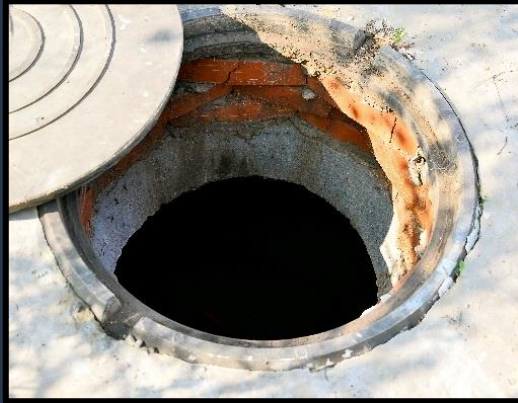
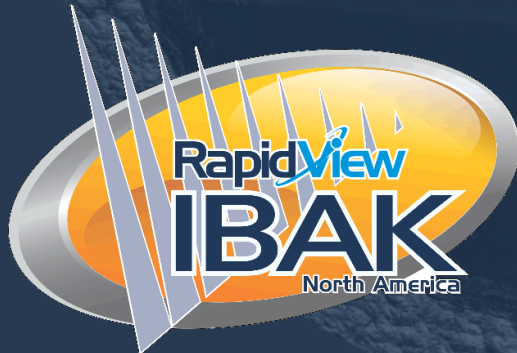
# Digital Manhole Inspection

- Accurate Point Cloud Measurements
- Identify Defects, Pipeline Locations and Inverts, Manholes, and Lining Materials
- No Manned Entry Required
- MACP Assessments

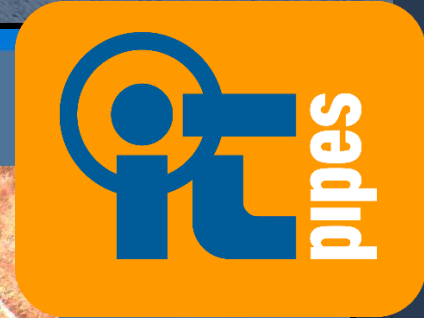
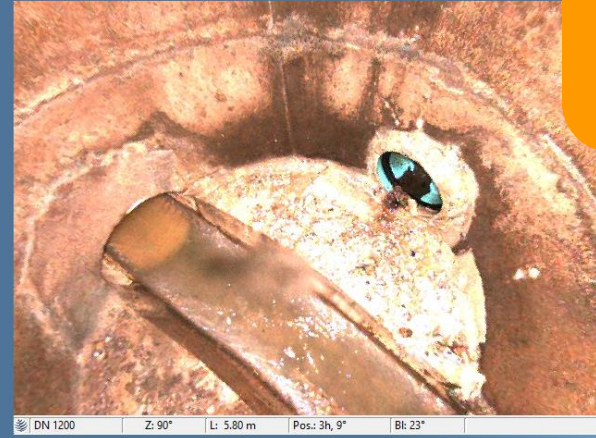
# Digital Manhole Inspection (continued)

Asset	
PO Number	
Weather	Dry
Date Cleaned	
Surveyed By	HECTOR
Certificate Number	U-1213-06015535
Sheet Number	0
Date	6/12/2018 4:16:06 PM
Purpose	Routine Assessment
Additional Info	ONE BOLT MISSING
Pre-cleaning	No pre-cleaning
Customer	NTMWD
Work Order	
Inspection Status	Remote Inspection
Evidence Surcharge	No
Potential for Runoff	None
Manhole Number	WWMH36705
Access Type	Manhole
MH Use	Sanitary

DN 1200 Z: 90° L: 5.80 m Pos: 3h, 9° Bl: 23°

0.5	Lining Failure Other				<input type="checkbox"/>	12	12	CEMENTUOUS LINER CRACKED AND BRICKS SHOWING		CMI	LFZ
0.5	Infiltration Stain				<input type="checkbox"/>	12	12			CMI	IS

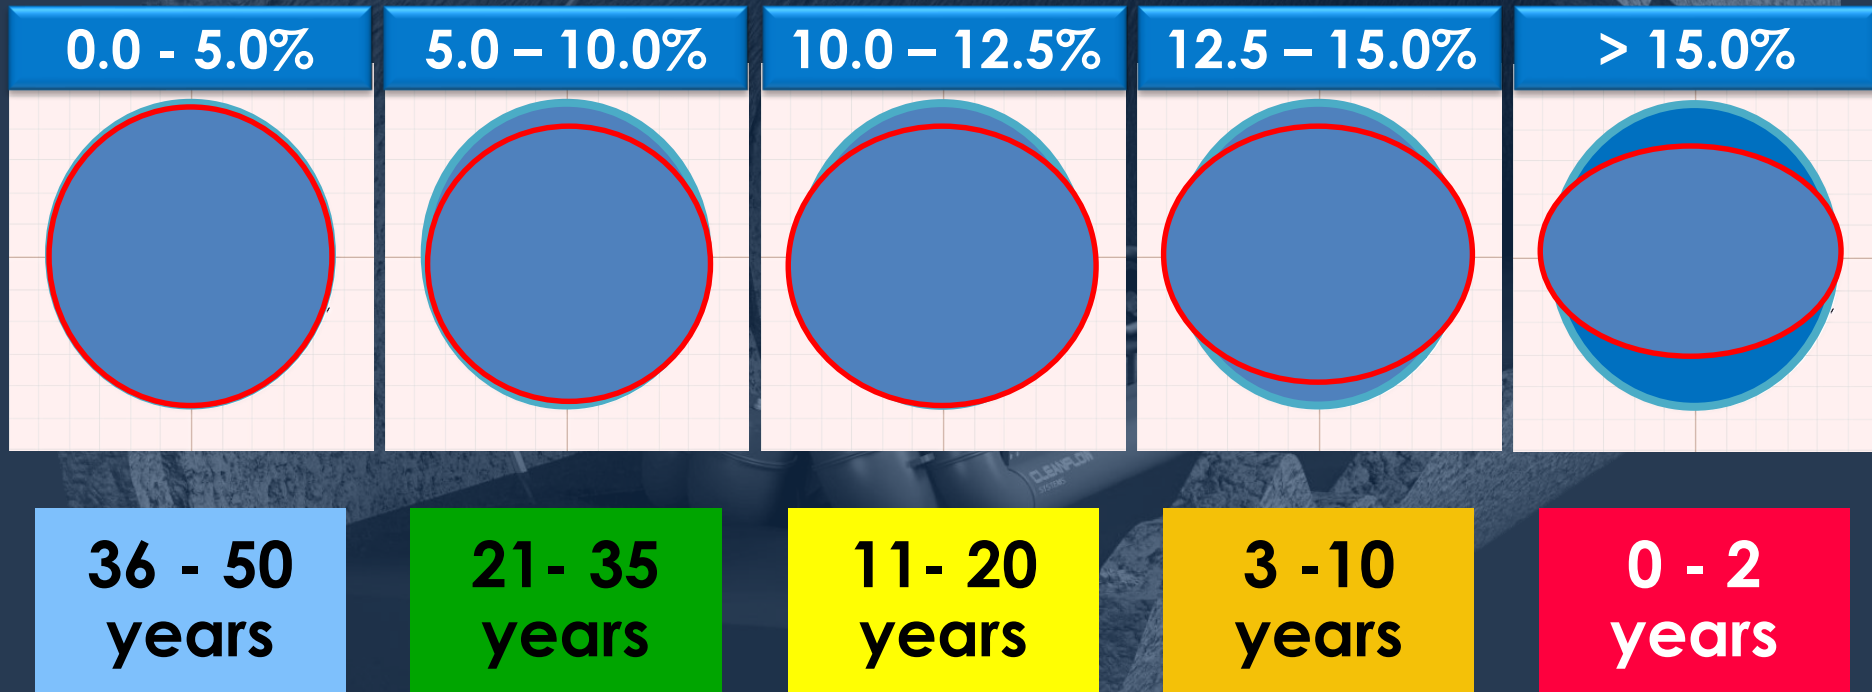
# Determining RUL - Flexible Pipes

RUL is automatically  
calculated for each ovality  
observation

*Pipe Manufacturers Specify  
5.0 – 7.5% Maximum Initial  
Deflection*

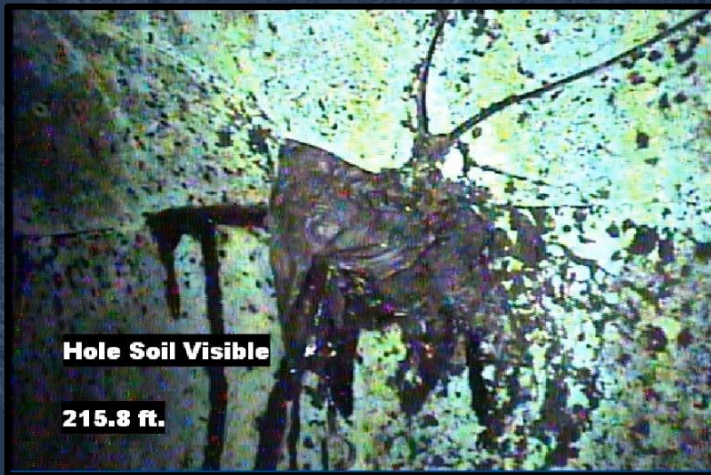
# Pipeline Inspection Point Defects

- 5 segments need point repairs to extend RUL
