# Asset Management at the Port of Vancouver

Vancouver Fraser Port Authority  
Engineering Department

# Example Asset Class: Shoreline Protection

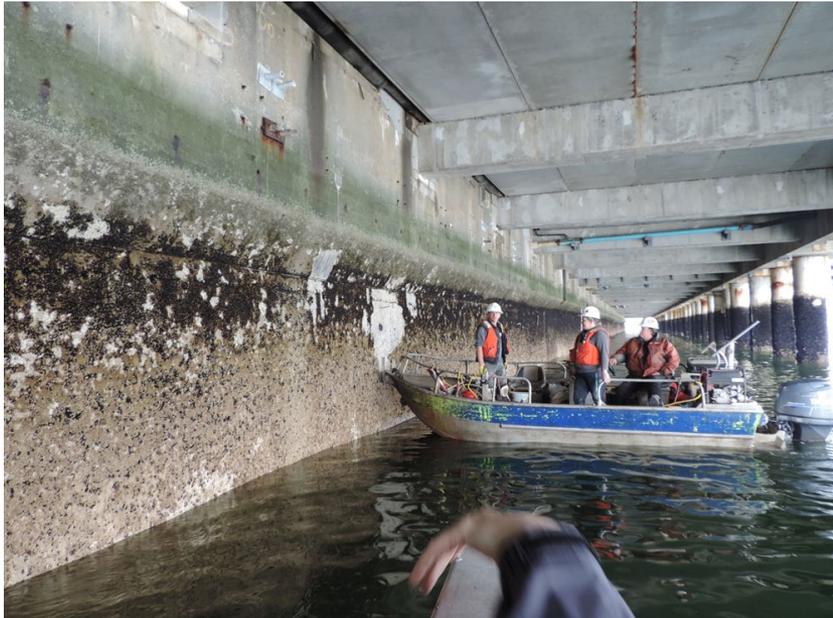
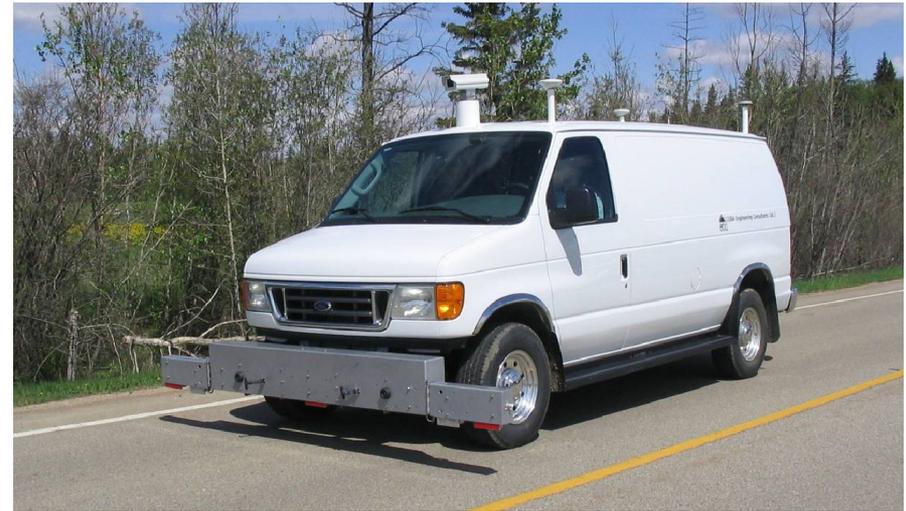
# Level 2, 3 Condition Assessments, Field Inspections

- Roadway surveys
- Bridge surveys
- Dock Structure surveys
- Pipe inspections

- Ultrasonic Thickness (UT) measurements
- Diving inspections
- Bathymetric data surveys
- Core sample lab testing

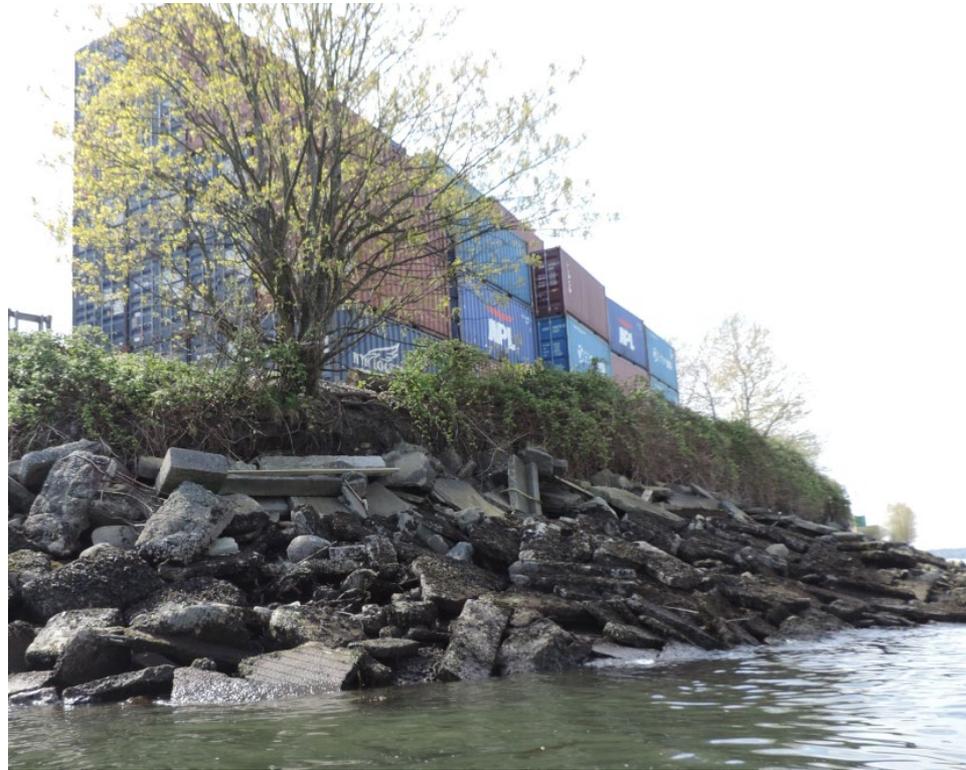
- Poorly graded stone fill
- Concrete demolition refuse
- Old sidewalk slabs
- No-post barriers, etc.

No filter stone or geotextile. Loss of fines over time.

Over-steep slopes, resulting in crest erosion, slumping, dangerous edges.

No consideration for marine environment. Harbour considered a dumping ground.

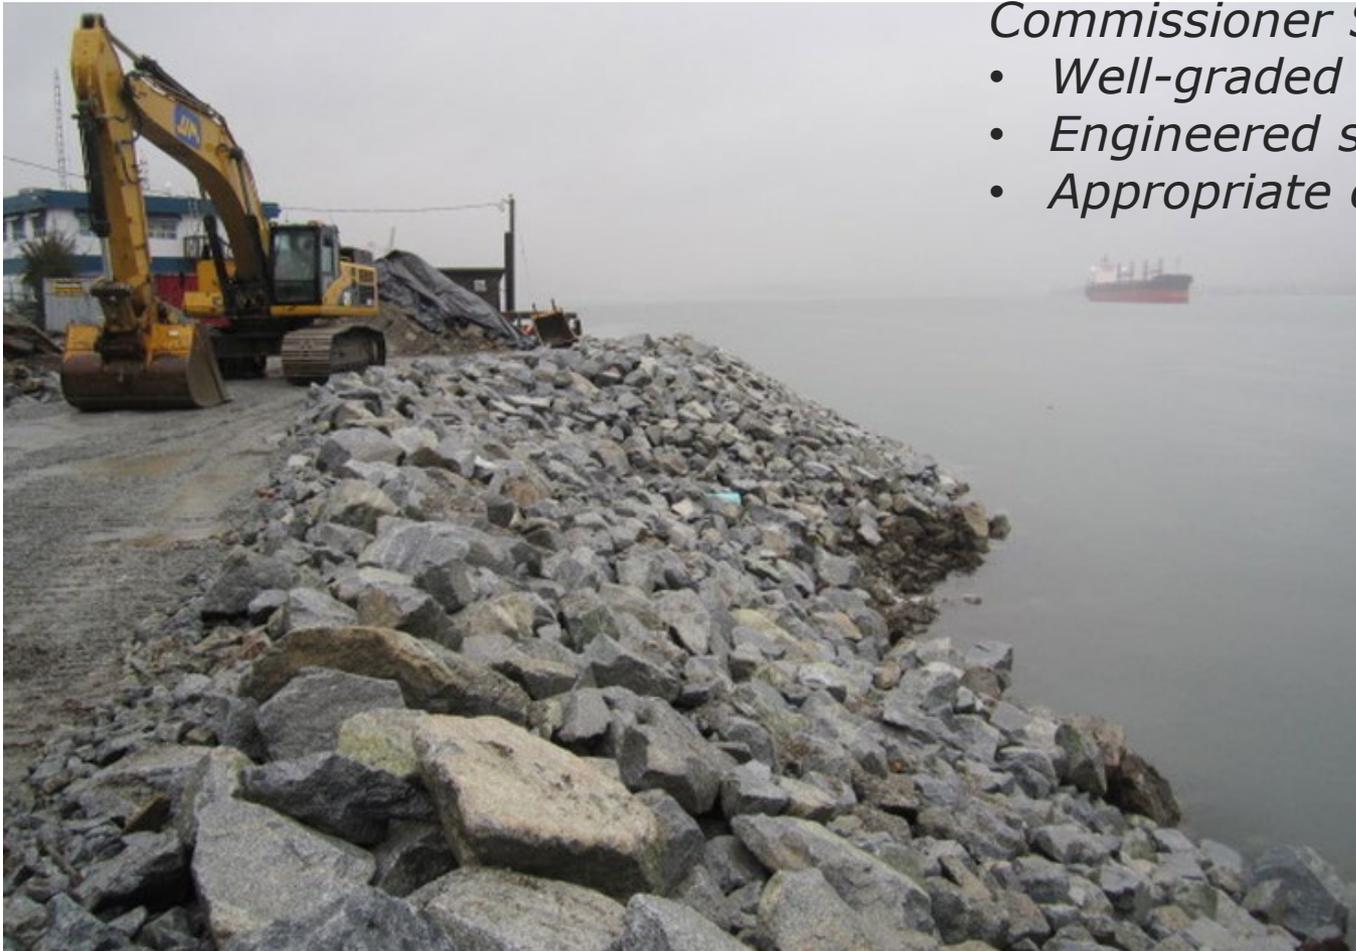
# Shoreline Protection Condition – The “Good”

- Recent repairs along  
Commissioner St, 2015:*
- *Well-graded stone size*
  - *Engineered slope*
  - *Appropriate crest height*

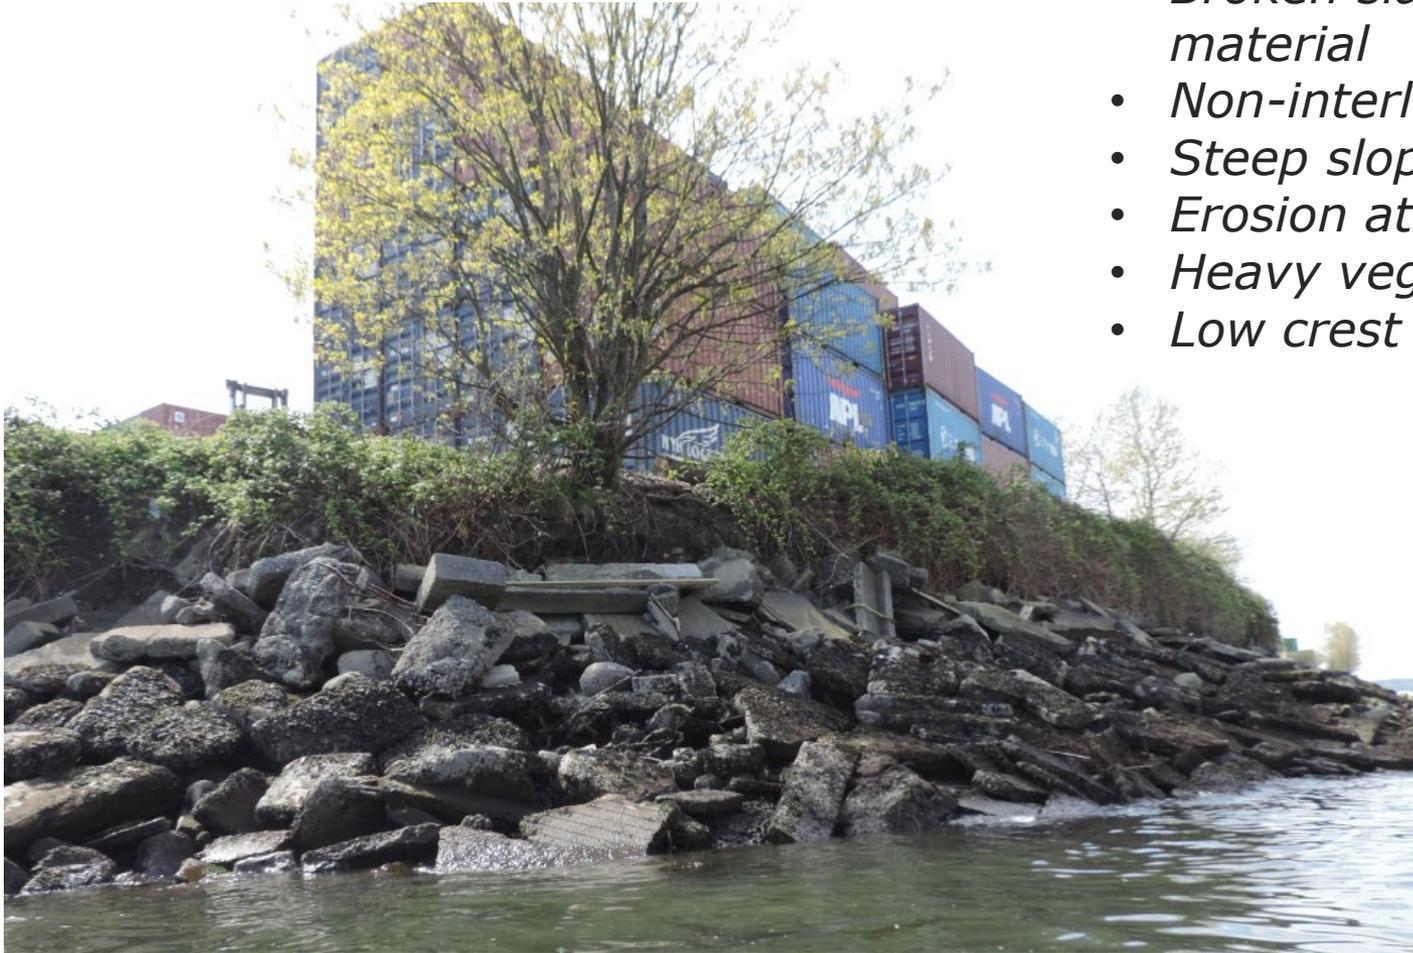
# Shoreline Protection Condition – The “Bad”

- *Broken slabs & waste material*
- *Non-interlocking*
- *Steep slopes*
- *Erosion at top of slope*
- *Heavy vegetation*
- *Low crest height*

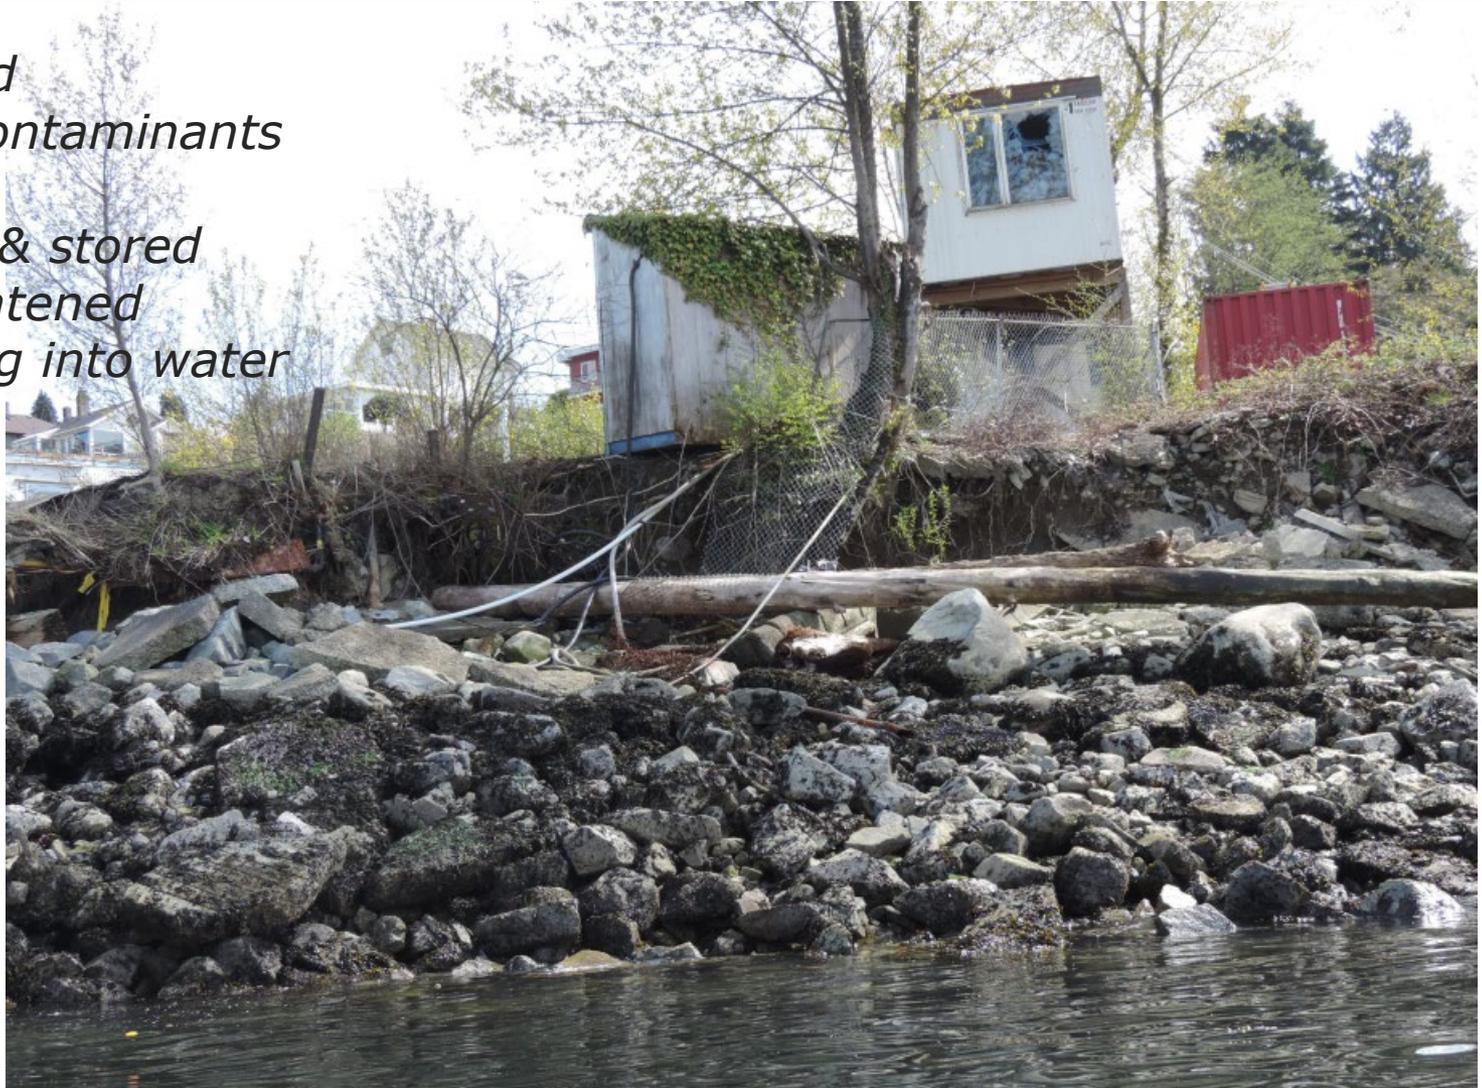
# Shoreline Protection Condition – The “Ugly”

- *Loss of land*
- *Potential contaminants exposed*
- *Structures & stored items threatened*
- *Trees falling into water*

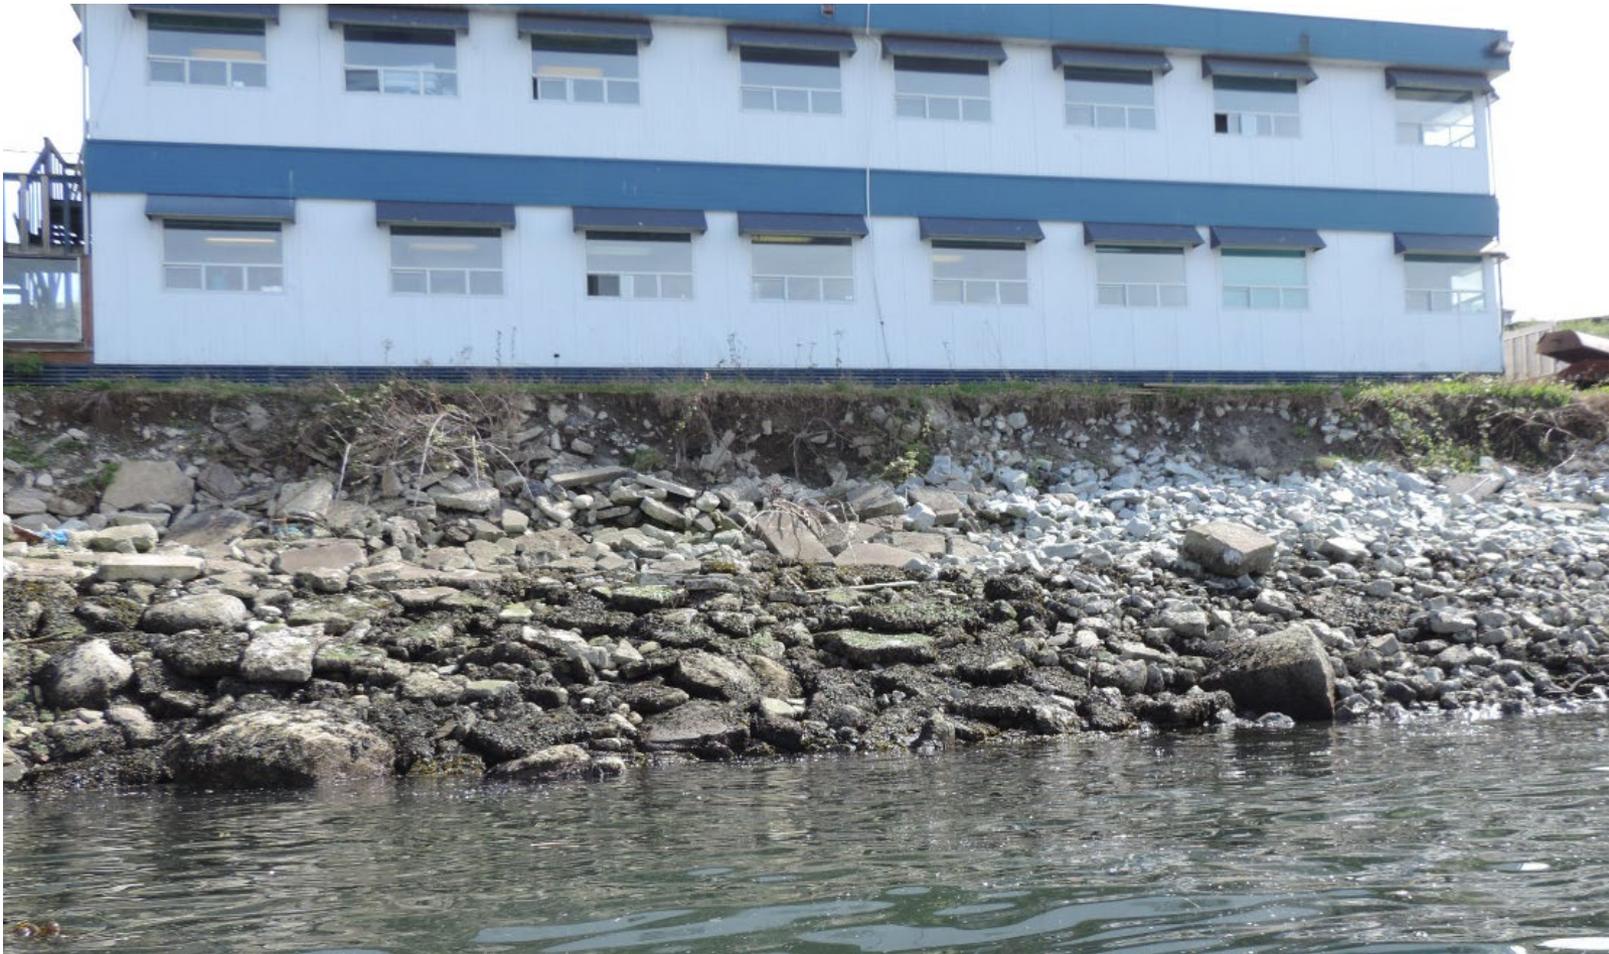
# More "Ugly"

*How much longer before this becomes a problem?*

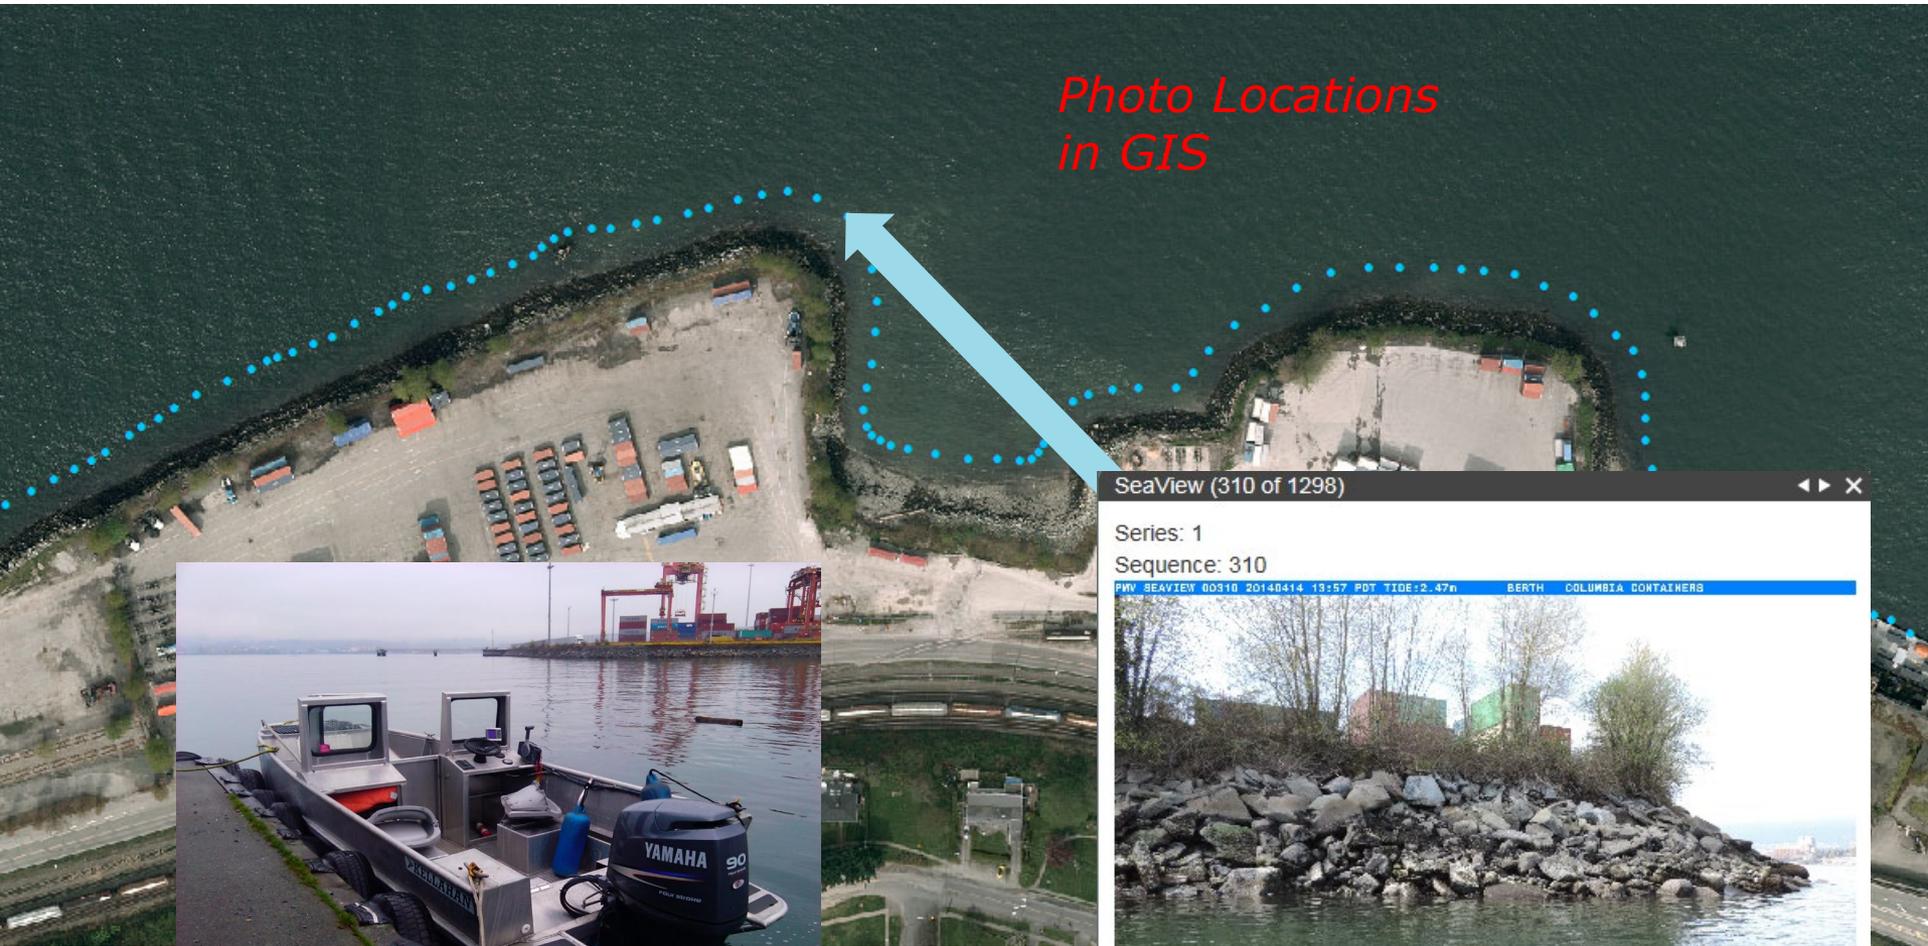
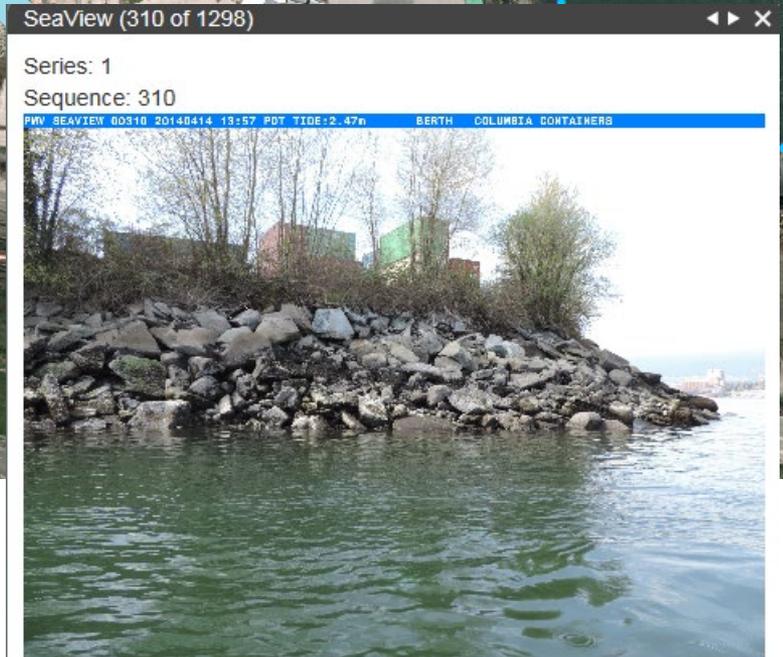
# Monitoring Programs: SeaView (Version 1)

*Photo Locations  
in GIS*

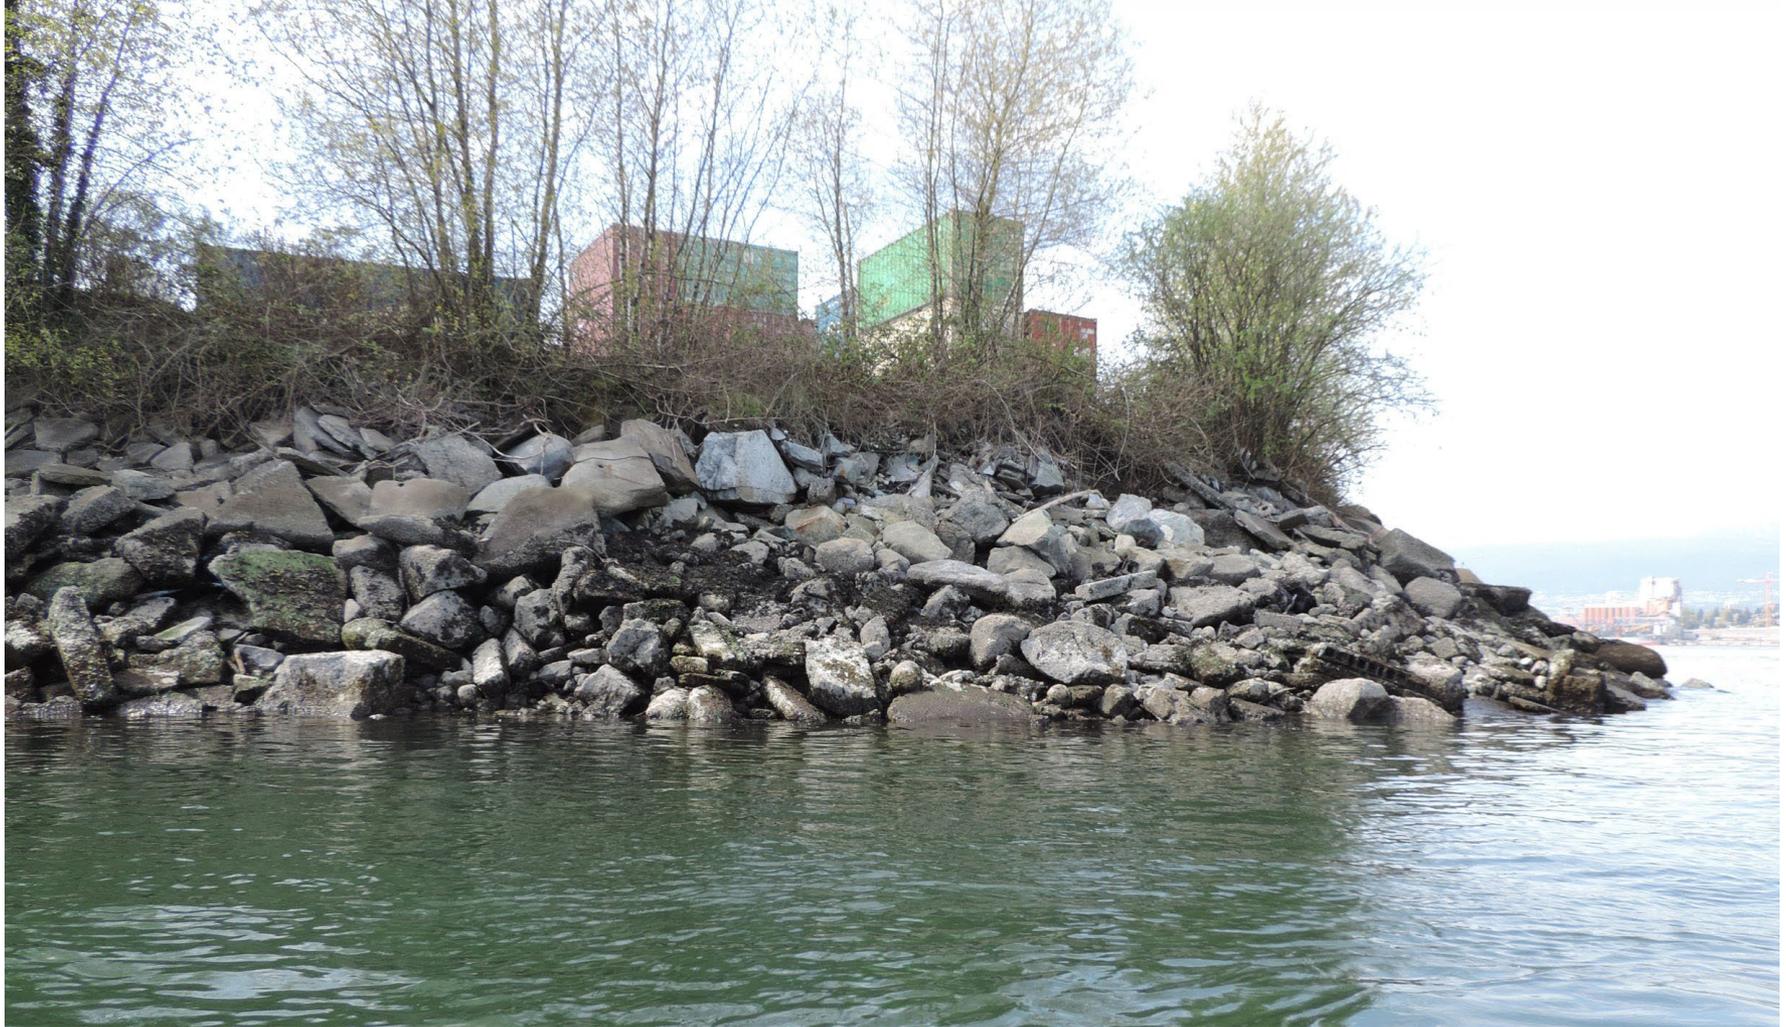
# SeaView (Version 1, 2014)

PMV SEAVIEW 00310 20140414 13:57 PDT TIDE:2.47m

BERTH COLUMBIA CONTAINERS

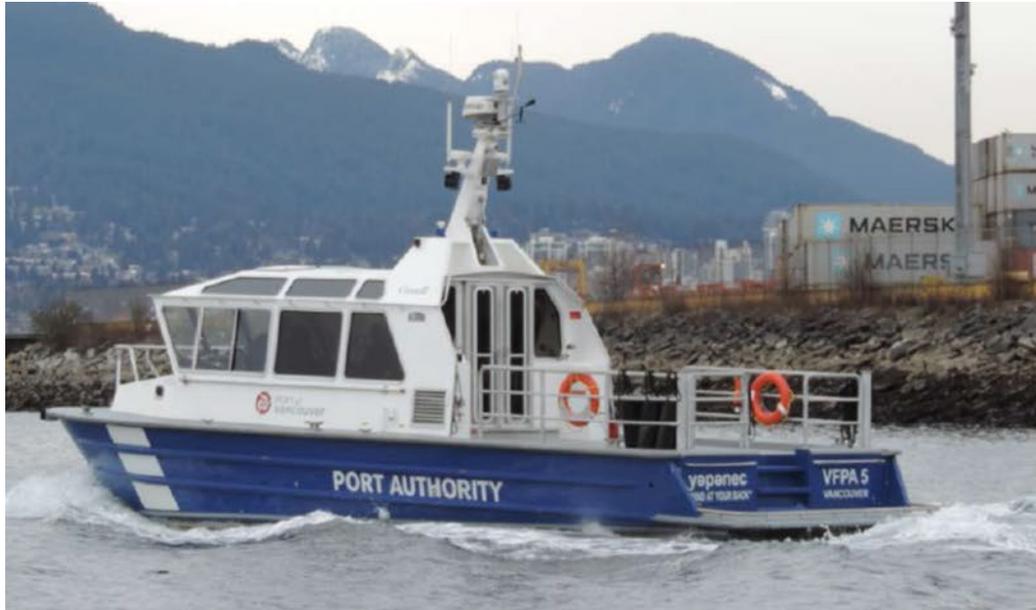
Harbour patrol boat  
*aka Aircraft Carrier*

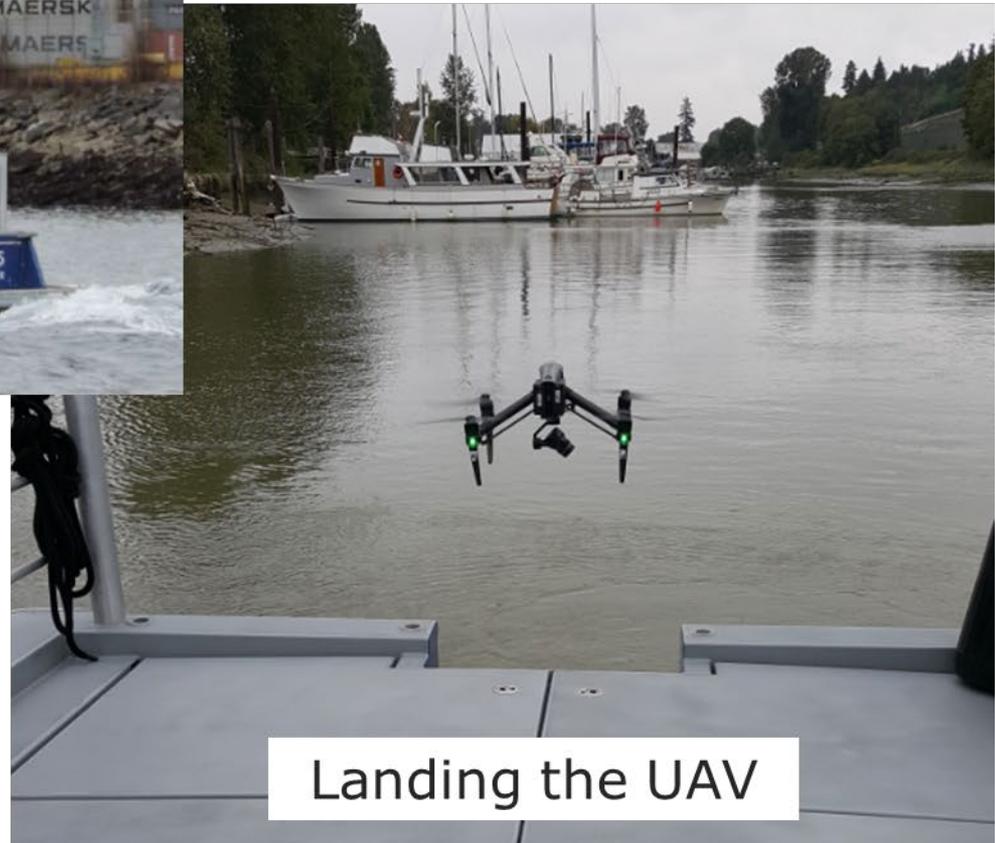
Landing the UAV

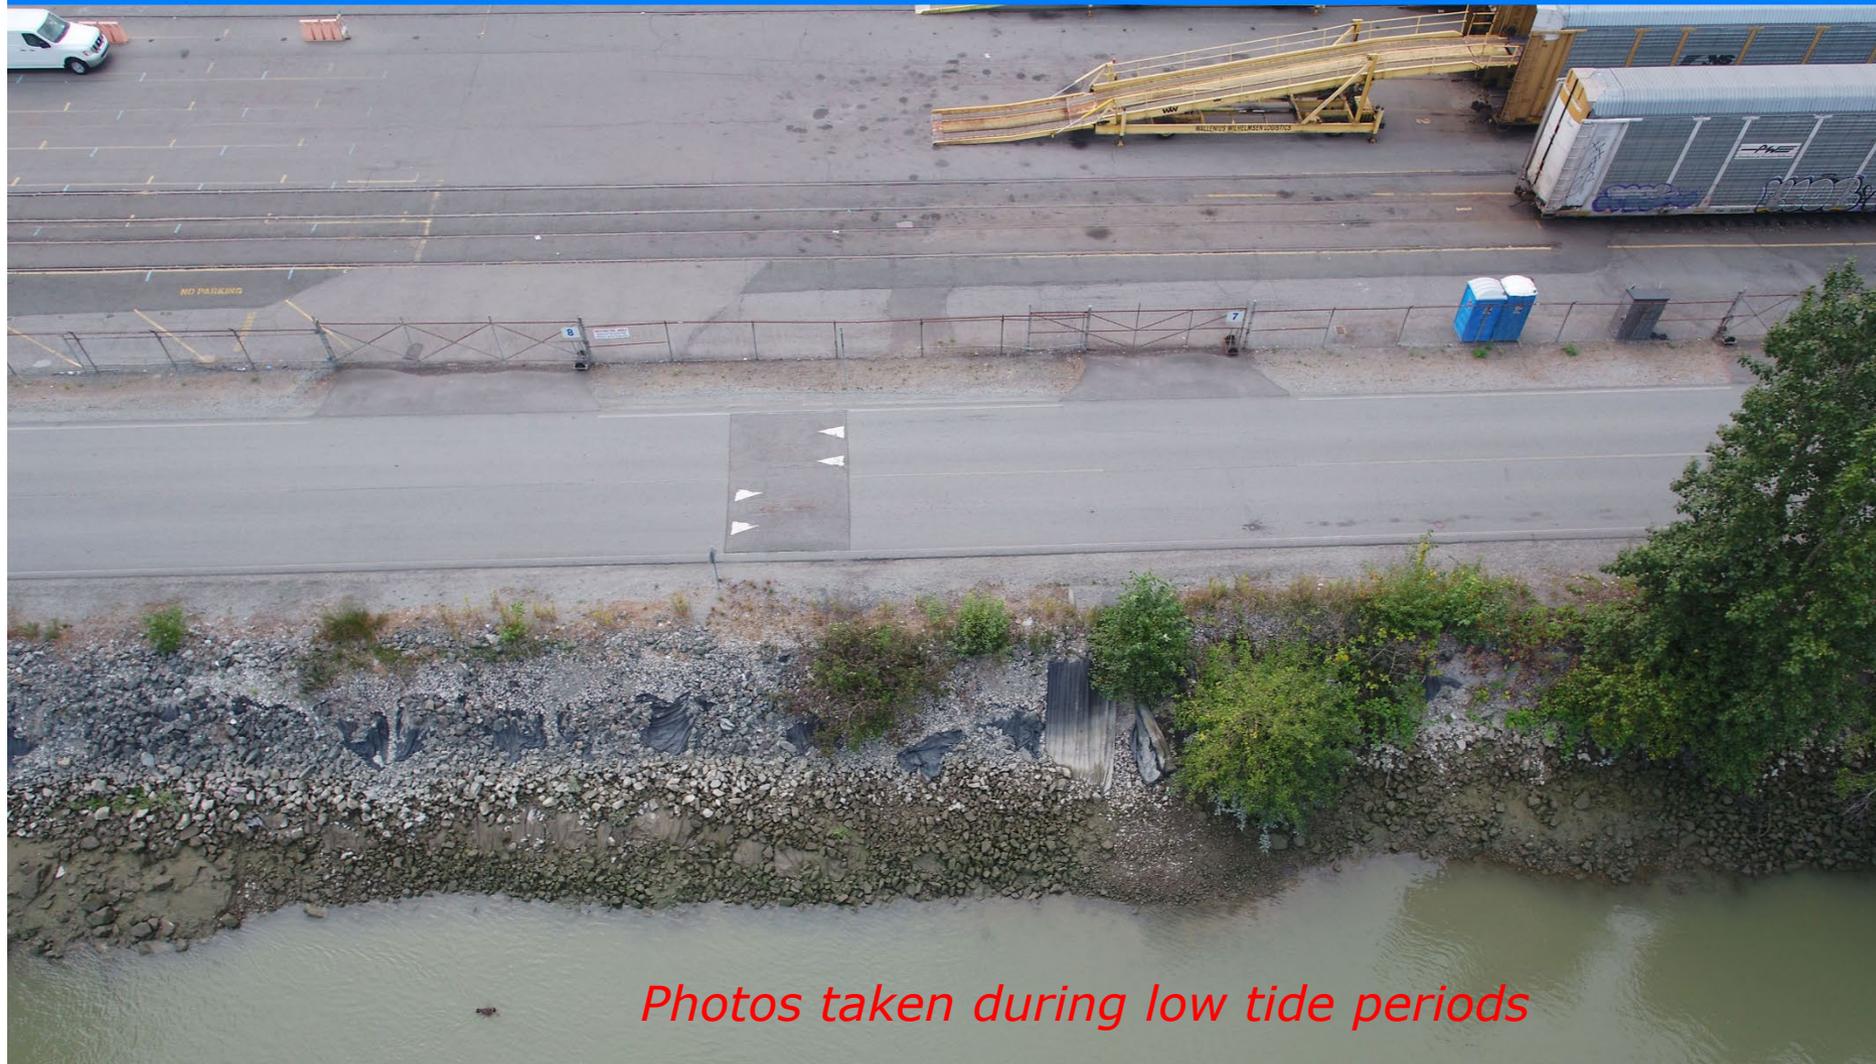
# SeaView, Version 2 – UAV (2018)

VFPA SEAVIEW 02\_0365 2018-08-24 10:27 PDT TIDE:0.852m Annacis Parkway

*Photos taken during low tide periods*
